The conservative restoration work

Negozio Olivetti before the restoration and consequent management of FAI

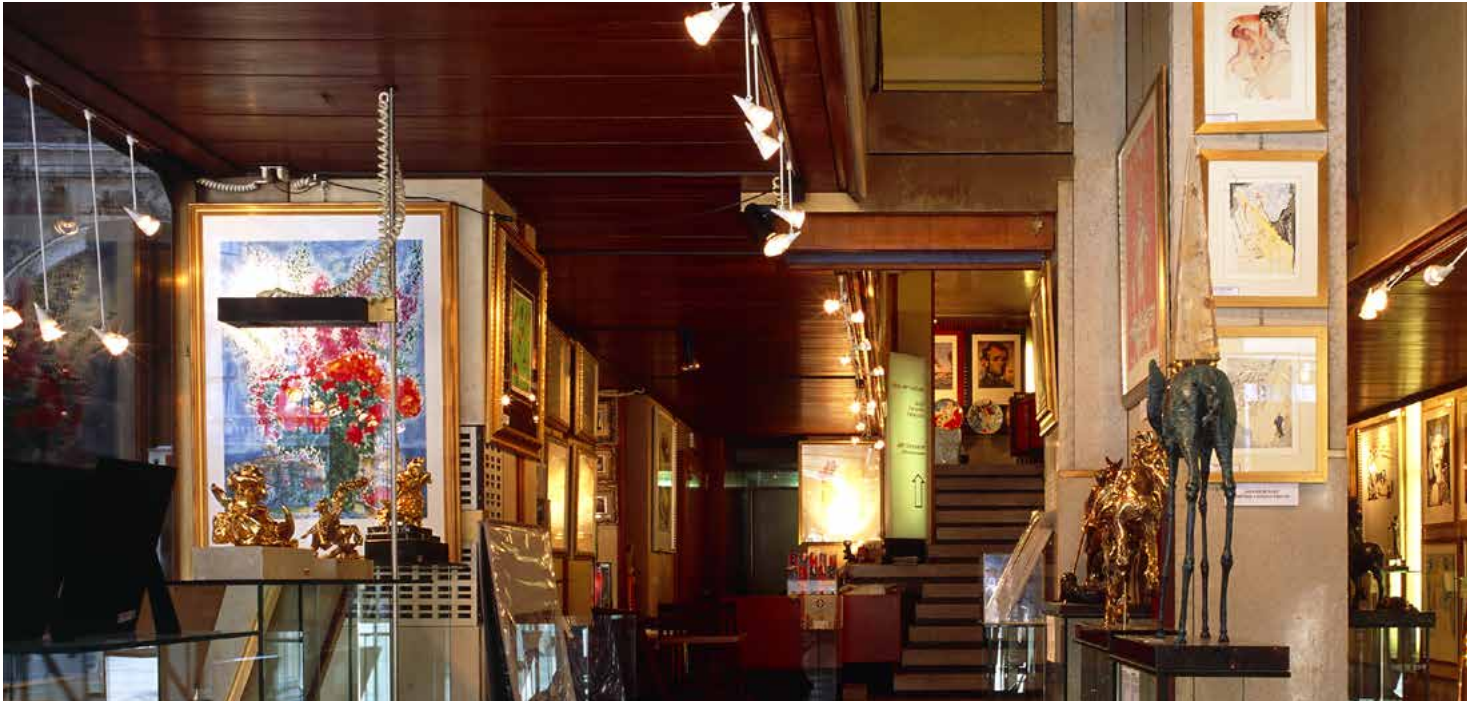
After Olivetti closed the Negozio in 1997, the premises were inadequately used for a touristy shop, inconsistent with the architectural quality of the place. Assicurazioni Generali, the owner, undertakes the restoration and **entrusts the management of the Venetian showroom.**

The first stage consists of the exploratory investigation of the space and its degradation to understand the nature of the damage. The modifications and a fire started on an unknown date in a room on the upper floor had deeply altered the Negozio, and the area around the staircase (claddings and stone in particular) had suffered many modifications.

After the investigation, the restoration work is performed according to the principle of minimal intervention.

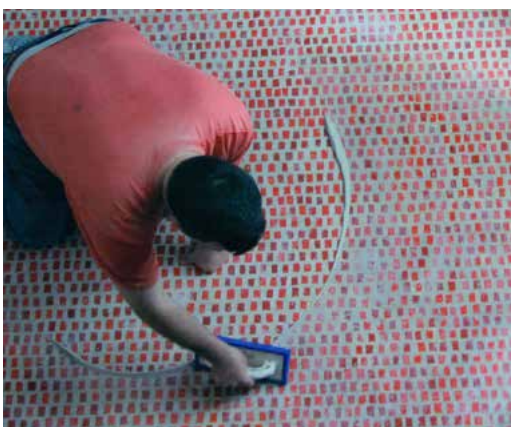
The Negozio is a precious site that needs great daily care after the challenging restoration. During the works, after the preliminary survey, thorough investigations and material samples (plasters, stuccos, paints) were conducted on the moisture and salinity levels of masonry, pulverization, detachments, bulges, and gaps in the floor together with the analysis of missing parts in the fixed and mobile furniture.

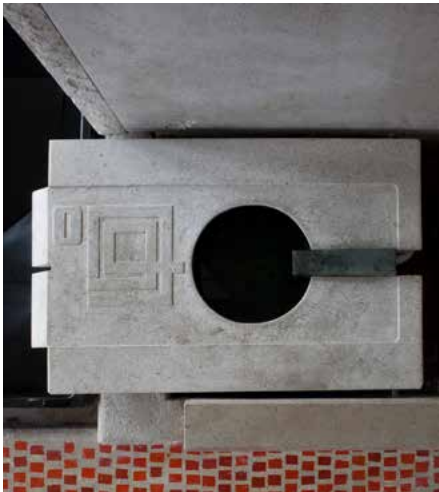
A detail of the sculpture by Viani after the restoration

The preliminary examinations of the restoration work shed light on the intended modifications, in the course of time, as compared to the degradation of the materials. A fire, for example, had blackened the walls and ceiling of a room on the upper floor while some original hues had been changed on purpose. The basin in black Belgian marble and the sculpture had a coat of dirt then removed.

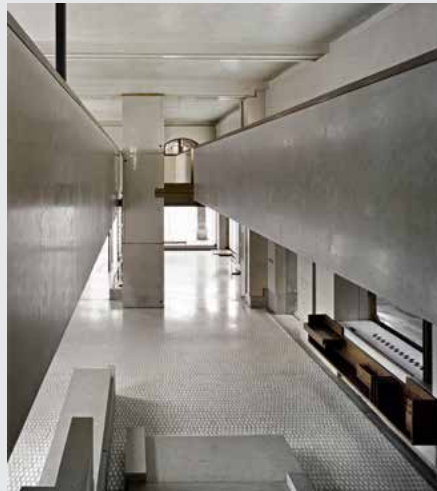
The surfaces after the restoration

During some works in 1984, all the surfaces in Venetian stucco had been covered with a yellow-ochre coloring that in some spots was shiny and reflective, contrasting with the grey hues of the Aurisina marble and the original color of the stucco. The more recent layer was removed to reveal the perfectly preserved original color. The initial material was unveiled to be still intact.

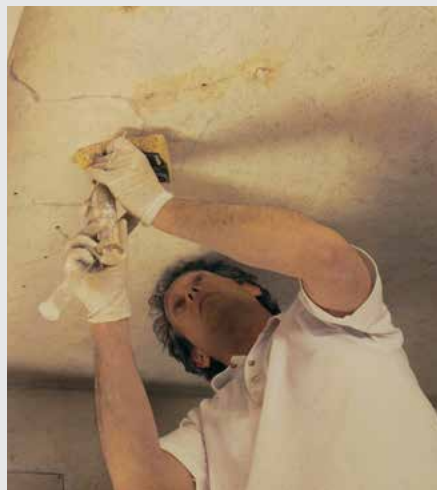
Cleaning the ceiling

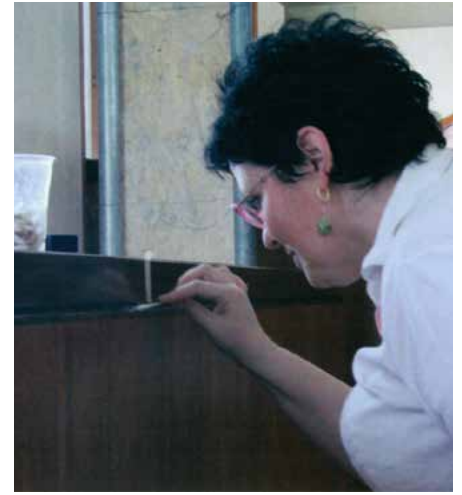
Conservative restoration of the wood elements

Tarnished after years of abandonment and inappropriate use, the wood surfaces were damaged and then were brought back to the original state according to each element of Carlo Scarpa's design. For its fragility, the *Negoziò* needs constant reliable care: FAI looks after it every day to preserve for the next generations this monument of great historical, artistic, social, and cultural value.

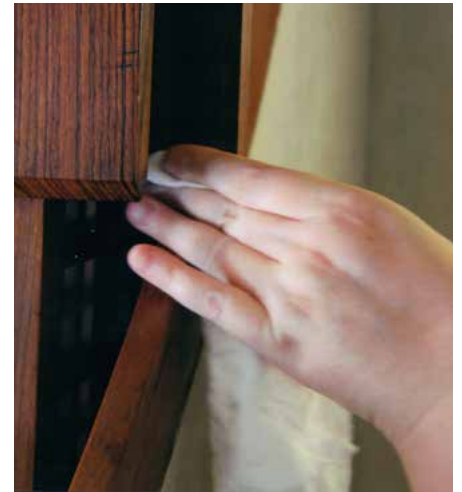
Dusting the wood elements
