THE RESTORATION WORKS

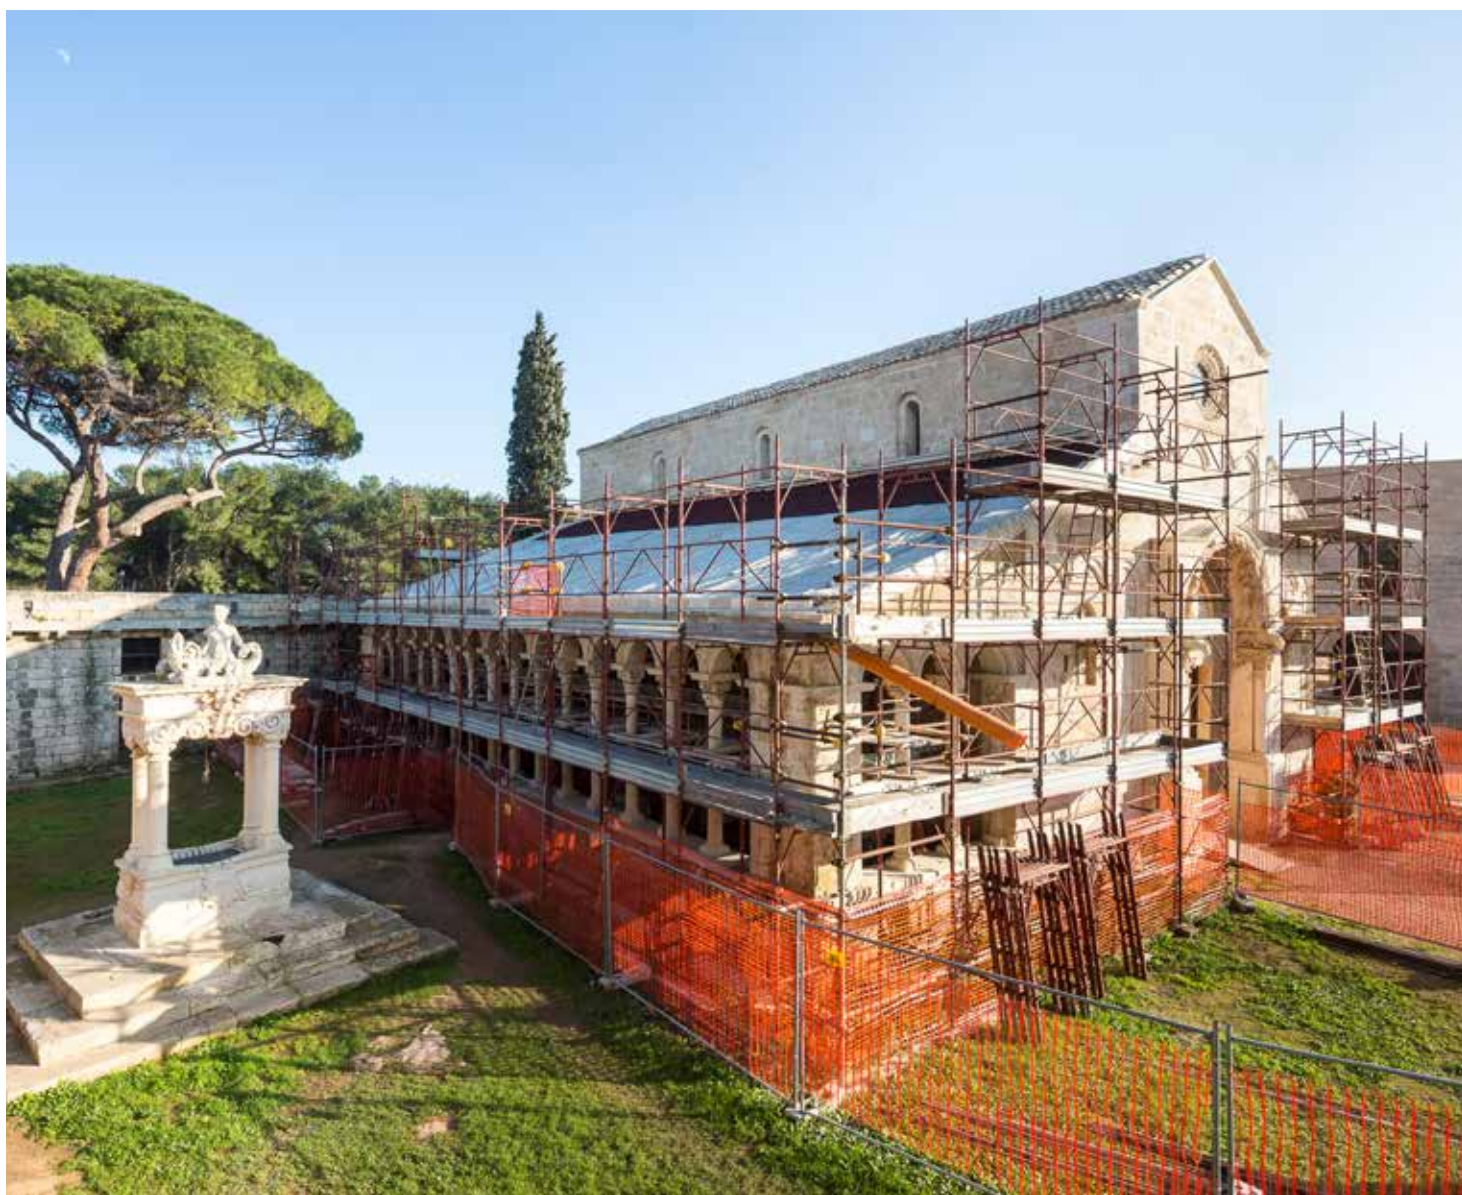
The works within the church were preceded by a major fact-finding exercise, taking in **multidisciplinary scientific research**, historical/artistic/archaeological/archival analysis and in-depth **diagnostic surveys**, which enabled the drafting of an effective plan. The conservative solutions chosen ensured the interpretation of the property in its complexity, taking account of the various historical phases and the different uses to which it was subject.

The **restoration** encompassed the roof, the load-bearing structures, the frames, the leaves of the facades and the significant sculptural cycle of the entrance portal and the portico (columns and capitals). The detailed preliminary **scanner survey** of the church made it possible for the

first time to map out exhaustively the structural features, the irregularities and the deformations, and to glean an understanding of the phases of construction and the modifications made over the centuries, facilitating the scheduling of targeted conservation and protection interventions. To deal with the rising damp affecting the walls, a new mesh for the capture and re-use of rainwater was installed, channelling the water to the cistern in the citrus grove.

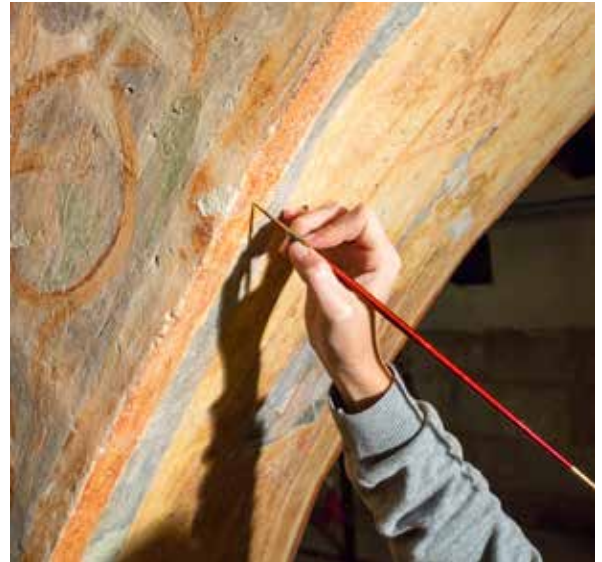
The wall paintings were deeply affected by the architectural changes made to the building over the centuries, as well as by traumatic events such as collapses and reconstructions, the series of decorative schemes, the microclimatic conditions and, last but not least, the restoration works carried out in the 1960s and '70s; it was in those years that a number of 14th- and 15th-century **frescoes were lifted off**, along with the **layers of plaster** that were obscuring the Byzantine paintings. Having conducted studies, diagnostic analyses and sampling, the restoration plan envisaged the phases of cleaning (with the use of laser technologies for the most stubborn dirt), the **removal of the remnants of old restorations** and, last but not least, **reintegration**. The operation reinstated the wall paintings' transparency and the brilliance of their ancient colours, and salvaged numerous important details, such as the inscriptions in Greek, which complete their narrative impact.
